Army Lodging Wellness Recommendation

Fort Leonard Wood - Draft Submittal

August 14, 2003

Fort Leonard Wood

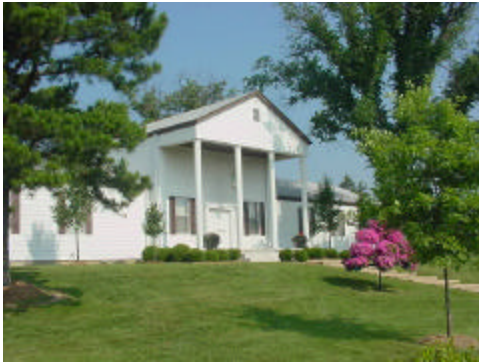
Building 430

Building 430, constructed in 1944 and renovated in 1999, is a single story structure housing 2 DVQ suites without full kitchens and a shared dining area, full kitchen, lounge, guest laundry and media room located between the two suites. The facility is in good condition but does not comply with the lodging size standards. The cost to renovate this building to the new Lodging standards and configuration will exceed the 50% replacement cost.

Our recommendation is to remove building 430 from the Lodging inventory, allowing the installation to determine an alternate use for this facility. This facility will be removed from the Fort Leonard Wood Wellness Solution and Lodging Master Plan.

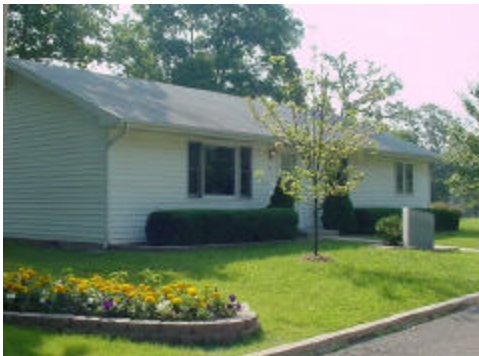
Building 441

Building 441, constructed in 1990, has one DVQ with a full kitchen. The facility is in good condition but does not meet current Army Lodging standards. The cost to renovate this building to the new Lodging standards and configuration will exceed the 50% replacement cost.

Our recommendation is to remove building 441 from the Lodging inventory, allowing the installation to determine an alternate use for this facility. This facility will be removed from the Fort Leonard Wood Wellness Solution and Lodging Master Plan.

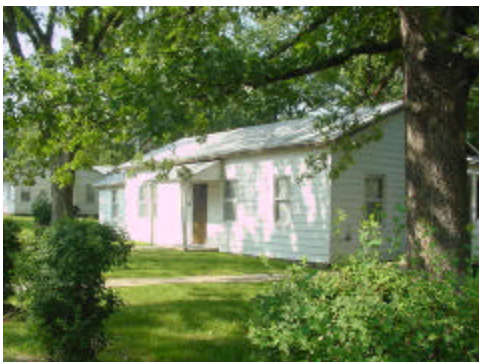
Building 443, 444, 446 and 448

Buildings 443, 444, 446, and 448, constructed in 1941, are single-story wood-framed buildings, each housing one family suite with full kitchen. The facilities are in fair condition but do not meet current Army Lodging standards. The cost to renovate these buildings to the new Lodging standards and configuration will exceed the 50% replacement cost.

Our recommendation is to remove buildings 443, 444, 446, and 448 from the Lodging inventory, allowing the installation to determine an alternate use for these facilities. These facilities will be removed from the Fort Leonard Wood Wellness Solution and Lodging Master Plan.

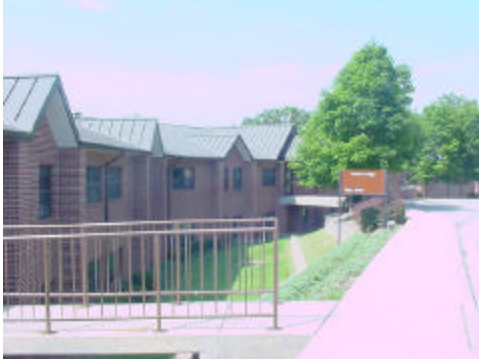
Building 2030

Building 2030, constructed in 1992, is a two-story brick building housing 70 2-bedroom suites with full kitchens. The rooms are accessed through 5'-0" wide interior corridors, and elevator access is not provided. This facility is in good condition, though the room sizes are slightly smaller than the standard at 400 square feet. It is felt this deficiency is not significant enough to renovate the room size considering the new age of this building. There are a few deficiencies in the back-of-the house and public space requirements. The cost to make condition assessment improvements and renovations to bring the building up to current Army Lodging standards will not exceed the 50% replacement cost.

Our recommendation is to retain building 2030 in the Fort Leonard Wood Lodging inventory. This facility will remain in the Fort Leonard Wood Wellness Solution and Lodging Master Plan.

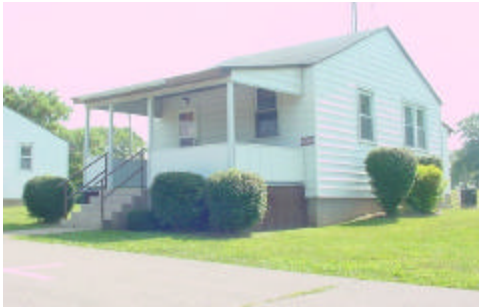
Building 2040, 2041, 2042 and 2043

Building 2040, 2041, 2042 and 2043, constructed in 1941, are all similar sized single-story wood-framed buildings, each housing one family suite with full kitchen. These facilities are in fair condition but do not meet current Army Lodging standards. To renovate these buildings to the new standards and configurations will exceed the 50% replacement cost.

Our recommendation is to remove buildings 2040, 2041, 2042 and 2043 from the Lodging inventory, allowing the installation to determine an alternate use for these facilities. These facilities will be removed from the Fort Leonard Wood Wellness Solution and Lodging Master Plan.

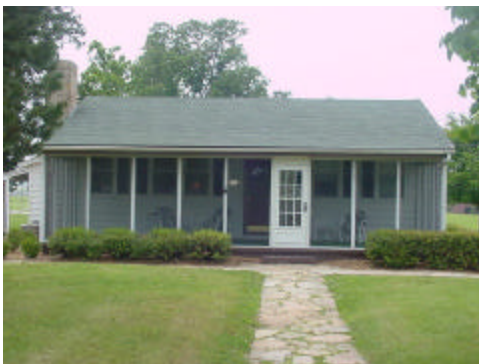
Building 2051

Building 2051, constructed in 1941, is a single story structure housing one DVQ suite with full kitchen. The facility is in good condition but does not meet current Army Lodging standards. The cost to renovate this building to the new standards and configuration will exceed the 50% replacement cost.

Our recommendation is to remove building 2051 from the Lodging inventory, allowing the installation to determine an alternate use for this facility. This facility will be removed from the Fort Leonard Wood Wellness Solution and Lodging Master Plan.

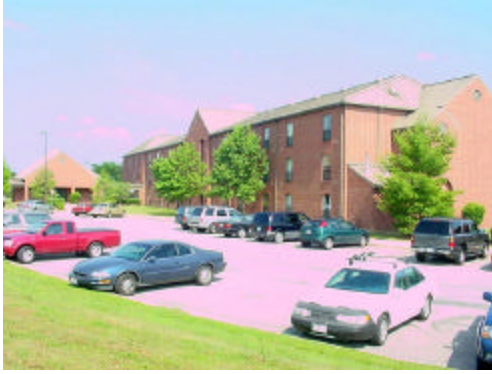
Buildings 3211, 3212, 3213, 3214

Buildings 3211, 3212, 3213, and 3214, constructed in 1989, are 3-story buildings. All of these facilities house 81 extended stay rooms with full kitchens and 6 family suites with full kitchens. Building 3212 also houses a breakfast area and snack area for this campus located within a converted room. Rooms are accessed via a 5'-0" wide interior hallway, and an elevator is included in each building. Additional public areas provided include gear wash rooms with private entrances and guest laundry and vending areas located on each floor. A separate support facility is located within this campus but is not included in this assessment.

These buildings are in fair condition and meet current Army Lodging standards. To meet the demand requirements, we recommend renovating the family suites to extended stay rooms. To make condition assessment improvements and renovations to bring these facilities up to the current Army Lodging standard will not exceed the 50% replacement cost.

Our recommendation is to retain Buildings 3211, 3212, 3213, and 3214 in the Fort Leonard Wood Lodging inventory. These facilities will remain in the Fort Leonard Wood Wellness Solution and Lodging Master Plan.

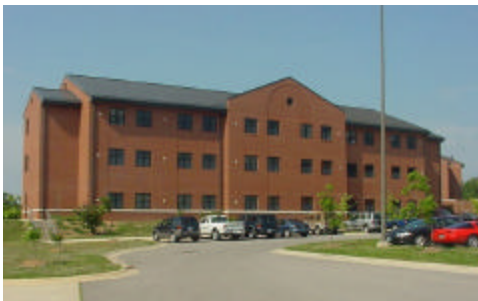
Buildings 3231, 3232, 3233, 3234, 3241, 3242, 3243, 3244, 3251, 3252, 3253 and 3254

These twelve brick buildings, constructed in 1999, are 4-story structures arranged into groups of four, with a single-story common building shared within each group. The single-story buildings (3230, 3240, and 3250) contains a guest laundry, break room, conference area, and breakfast area but are not included in this assessment. Buildings 3231, 3232, 3234, 3241, 3242, 3243, 3244, 3251, 3252, 3253 and 3254 house 72 rooms each, with each pair of rooms sharing a kitchen and bath area. Building 3233 houses 96 rooms, with each pair of rooms sharing a kitchen and bath area. These buildings are in good condition but do not comply with current Army Lodging standards.

Due to the new age of this building, we recommend removing the common wall between the pairs of rooms, providing slightly oversized extended stay rooms which generally meet Lodging standards. The cost to make condition assessment and renovation improvements will not exceed the 50% replacement cost.

Our recommendation is to retain buildings 3231, 3232, 3233, 3234, 3241, 3242, 3243, 3244, 3251, 3252, 3253, and 3254 in the Fort Leonard Wood Lodging inventory. These facilities will remain in the Fort Leonard Wood Wellness Solution and Lodging Master Plan.

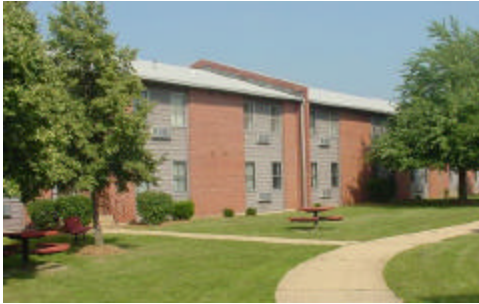
Buildings 4100, 4101, 4102, 4103, 4104

Buildings 4100, 4101, 4102, 4103, and 4101, constructed in 1965 and 1966 and renovated between 1998 and 2000, are 2-story brick buildings. Buildings 4100 and 4101 house 32 extended stay rooms with full kitchens and 8 family suites with full kitchens. Building 4102 has 35 extended stay rooms with full kitchens, 8 family suites with full kitchens, and a breakfast area and snack area for this campus located within a converted room. Building 4103 has 40 extended stay rooms with full kitchens and 4 family suites with full kitchens. Building 4104 has 39 extended stay rooms with full kitchens and 8 family suites with full kitchens. Rooms are accessed through a narrow 4'-0" interior hallway, and elevator access is not provided. These buildings are in good condition.

These buildings are in good condition and meet current Army Lodging standards. To meet the demand requirements, we recommend renovating the family suites to extended stay rooms. To make condition assessment improvements and renovations to these facilities will not exceed the 50% replacement cost.

Our recommendation is to retain buildings 4100, 4101, 4102, 4103, and 4104 in the Fort Leonard Wood Lodging inventory. These facilities will remain in the Fort Leonard Wood Wellness Solution and Lodging Master Plan.

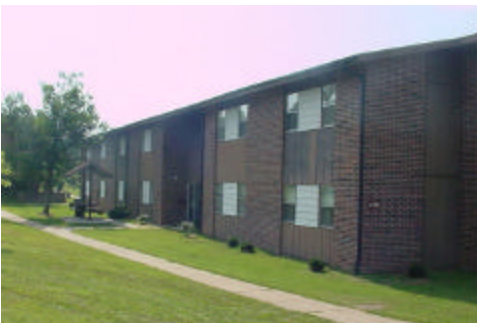
Buildings 4110, 4111, 4112

Buildings 4110, 4111, and 4112, constructed in 1973, are 2-story brick facilities. Buildings 4110 and 4112 both house 25 extended stay rooms with full kitchens. Building 4111 houses 24 extended stay rooms with full kitchen. Though these buildings meet current Army Lodging standards, they are in poor condition. To make condition assessment improvements to these facilities will exceed the 50% replacement cost.

Our recommendation is to remove buildings 4110, 4111, and 4112 from the Lodging inventory, allowing the installation to determine an alternate use for the facilities. These facilities will be removed from the Fort Leonard Wood Wellness Solution and Lodging Master Plan.

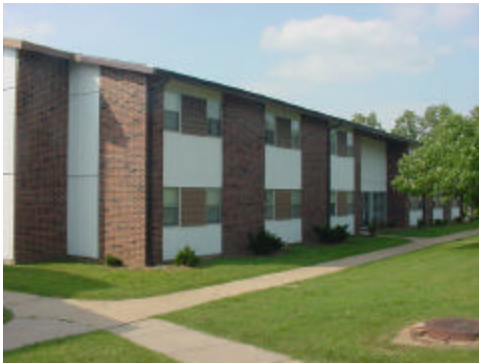
Buildings 4113, 4114, 4115

Buildings 4113, 4114, and 4115, constructed in 1973 and renovated in 1998, are 2-story brick facilities. Building 4113 houses 16 family suites with full kitchen, and a breakfast area for the Lodging inventory is housed in a converted room. Buildings 4114 and 4115 both house 17 family suites with full kitchens. Though these buildings meet current Army Lodging standards, they are in poor condition. To make condition assessment improvements to these facilities will exceed the 50% replacement cost.

Our recommendation is to remove buildings 4113, 4114, and 4115 from the Lodging inventory, allowing the installation to determine an alternate use for the facilities. These facilities will be removed from the Fort Leonard Wood Wellness Solution and Lodging Master Plan.

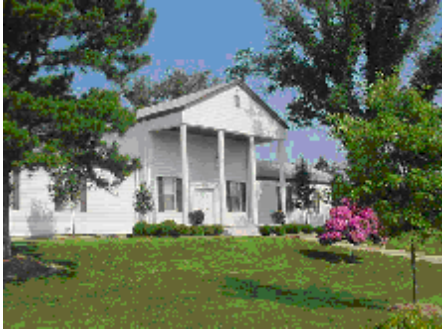
Building 0430

Building 430 was constructed in 1944 and renovated in 1999. The 4,100 square foot facility contains 2 lodging units operating as 2 DVQs.

Renovation Cost	\$834,370.00
Replacement Cost	\$1,074,165.00
Renovation to Replacement Cost Ratio	77.68%

Because the Renovation Cost to Replacement Cost Ratio is greater than 50%, renovation of Building 430 is not recommended.
